REPORT NO. 3763
NORFOLK SOUTHERN RAILWAY COMPANY
IN RE ACCIDENT
NEAR EDENTON, N. C., ON
JULY 5, 1957

Accident near Edenton, N. C., on July 5, 1957, caused by
failure of a trestle.

Report No. 3763
Norfolk Southern Railway
Edenton, N. C.
July 5, 1957

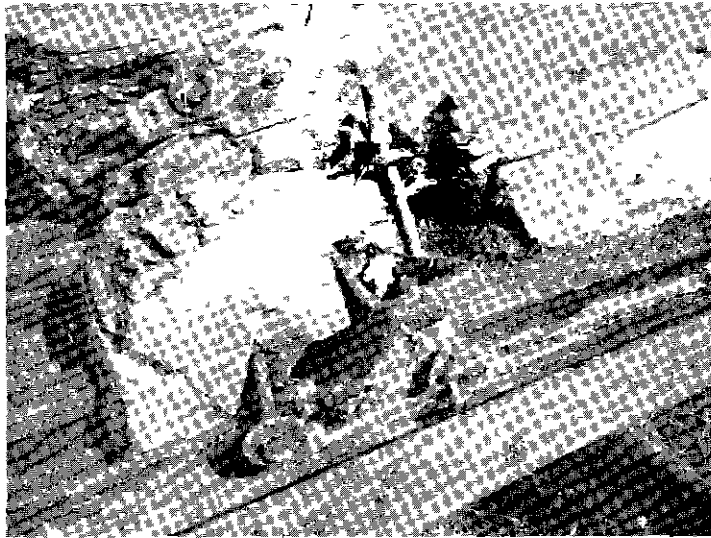
In the vicinity of the point of accident the trestle consisted of frame-type bents. The penetration of the piles was approximately 40 feet. At low tide the depth of the water is about 20 feet. The water level varies approximately 2 feet. There was no indication that equipment had been derailed before the trestle failed. The frames of 11 bents were destroyed when the accident occurred. Twenty-one piles of these bents remained in place. Since only about 20 percent of the trestle members involved in the accident were recovered, the sequence of events that led to the failure of the trestle could not definitely be determined. There was no indication of damage to the piles by marine borers. One batter post of a frame involved in the accident was decayed near the bottom end to the extent that only approximately 30 percent of the original cross-sectional area was effective in bearing the load applied to the post. (See Plate 1.)

Plate 1. Showing the extent of decay found at the bottom end of a batter post of one of the frame-type bents involved in the accident.

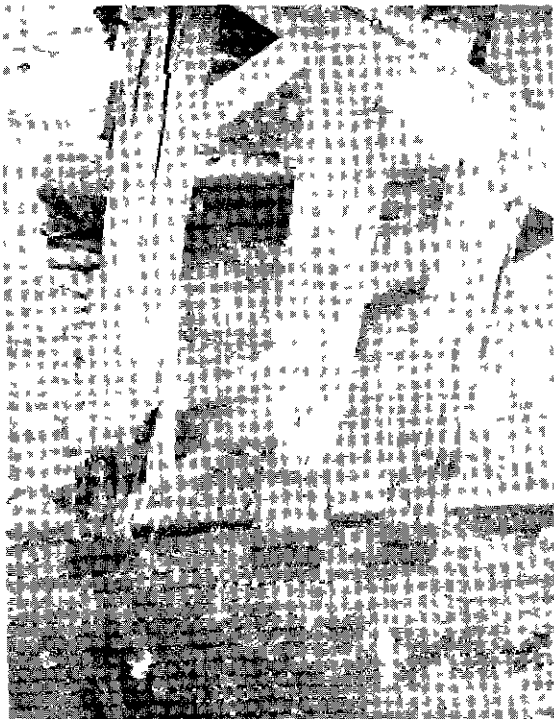
Plate 2. Showing failure of the east outside batter pile of an original full-pile bent because of decay; also shows longitudinal split.

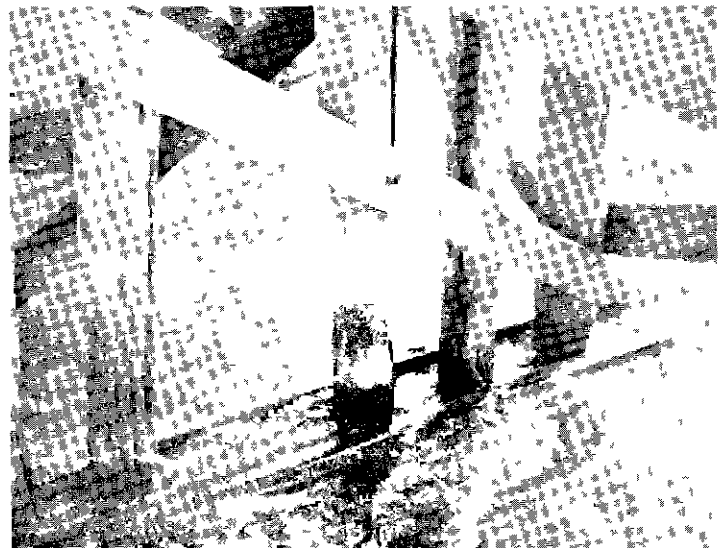
Plate 3. Showing extent of decay in other piles of the original full-pile bent shown in Plate 2.

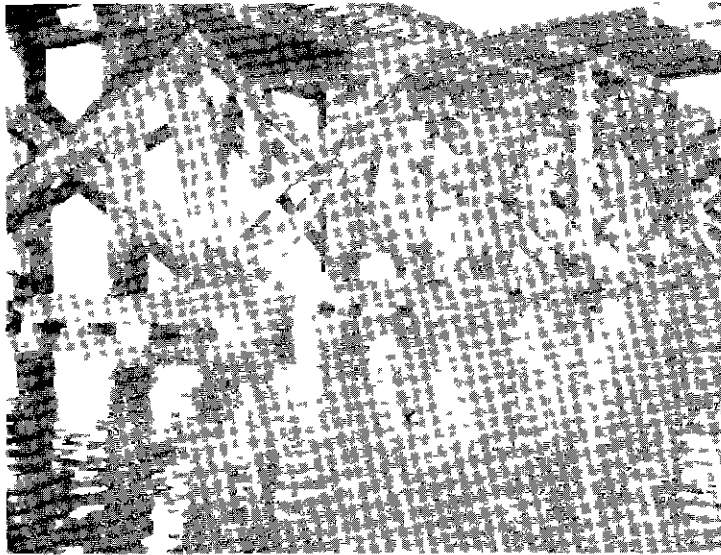
have been distributed over six piles. A considerable number of frame-type bents were found in which the sill was not bearing on the outside batter pile. In some cases the pile was missing or had moved from its proper location, and in other cases the pile was in its proper location but the top of the pile had deteriorated to the extent that it was not in contact with the sill. (See Plates 4 and 5.) Under that condition the unsupported end of the sill was required to withstand the force transmitted by the batter post and high bending stresses were produced in the sill where it was supported by the inside batter post. Two bents were found in which the sills had failed because the top of the outside batter pile was not in contact with the sill. (See Plates 6 and 7.) In each case the outside batter pile was in its proper location and prevented the sill from breaking off completely. It is probable in each of these cases that if the outside batter pile had moved from its proper location or had been missing the bent would have failed.

Plate 4. Showing outside batter piles of frame-type bents which have moved from proper location or are missing.

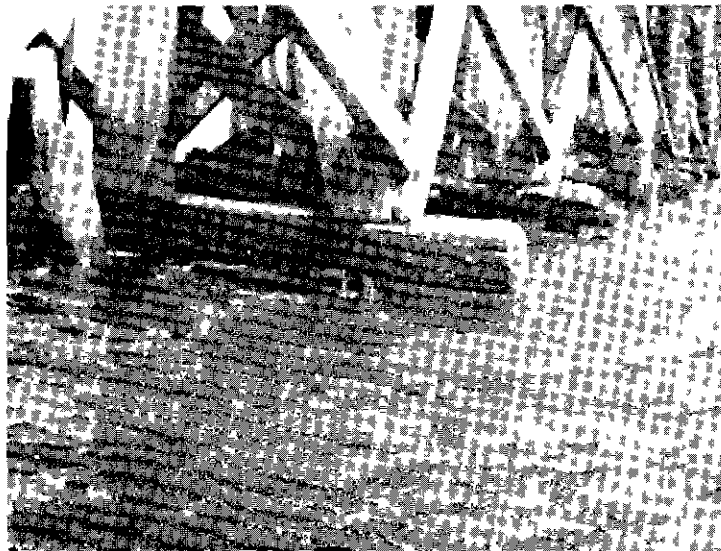
Plate 5. The top of the outside batter pile in the foreground had deteriorated to the extent that the base sill is not bearing on it. Note that the nearest point of support on the base sill is provided by the pile under the plum post.

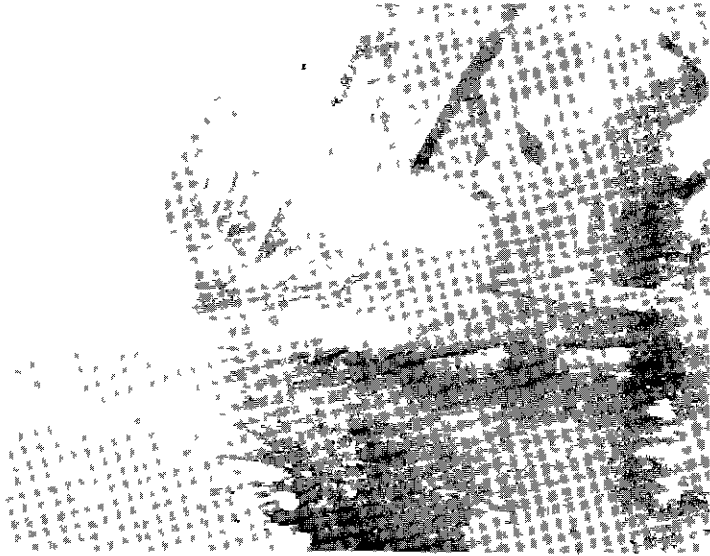
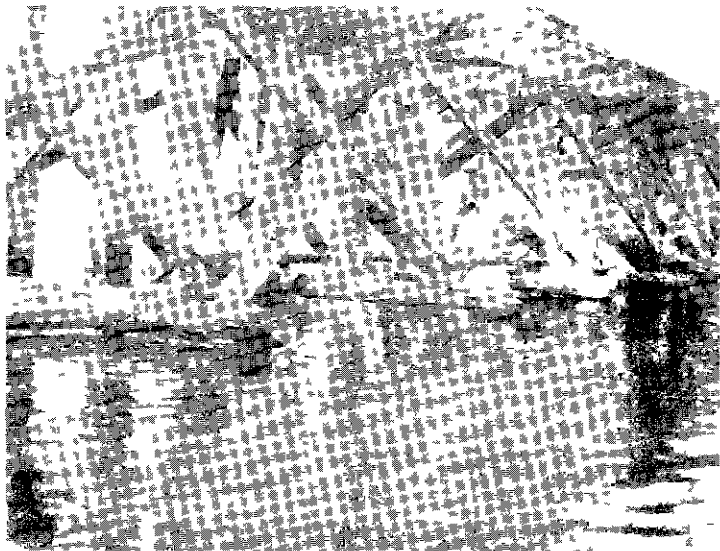
Examination of the remaining portion of the trestle from the deck after the accident occurred disclosed that a large number of ties were in various states of decay. None of the decayed ties were adjacent to each other. A number of stringers were decayed but not more than one decayed stringer was found in any group of three stringers on either side of the trestle. Examination from the water level disclosed that a number of piles of the bents containing the original full piles were in various states of decay. The outside batter pile of one of these bents had split longitudinally and had decayed near the water line to the extent that it had failed. Two other piles in this bent were considerably decayed. (See Plate 2 and 3.) The tops of the piles supporting the frames of a considerable number of frame-type bents had deteriorated to the extent that the sills were not bearing on them. Some of these bents had as many as three piles in that condition with the result that the sill was subjected to high bending stresses and three piles were bearing a load which should

Showing failure of base sills of frame-type bents because of deterioration of the tops of the outside batter piles.
